## **Report on Geotechnical Investigation**

**The Sanctuary Stage 7**

**Brush Cherry Boulevard, Thrumster NSW**

**Project 209310.05**

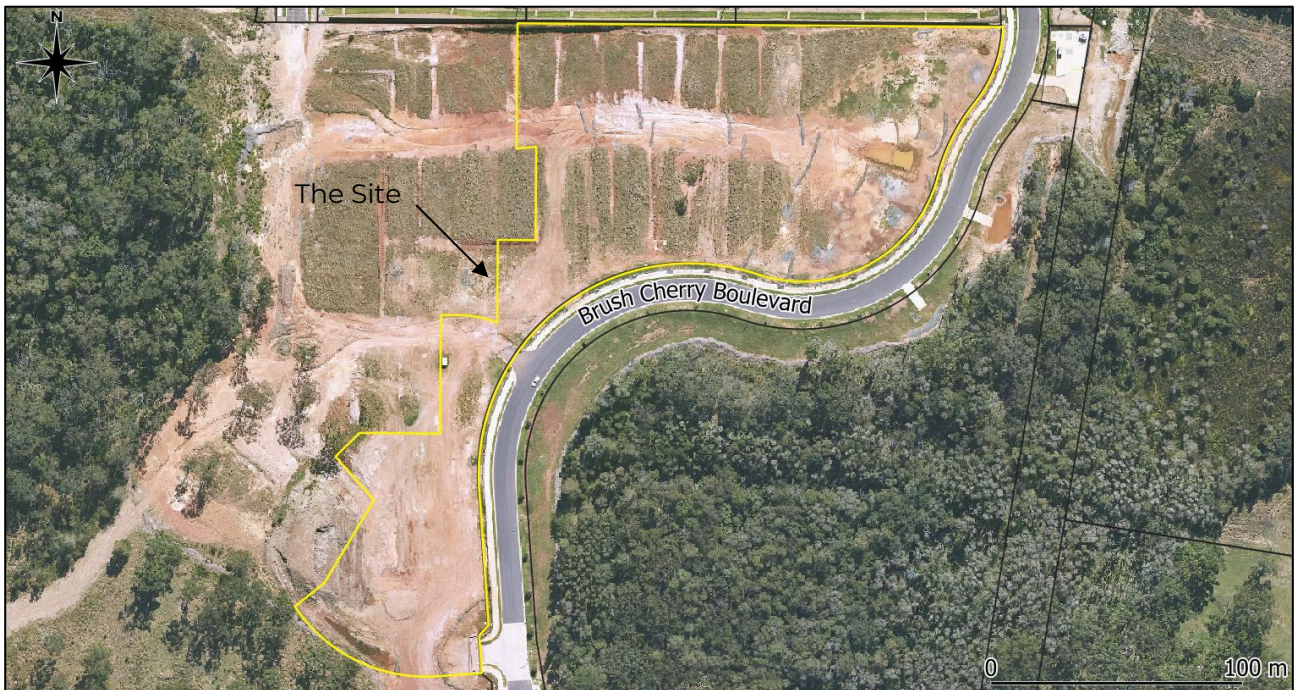
**Figure 1: Site location plan (image source: Metromap Image dated 1 September 2024)**

Stage 7 comprises thirty-one (31) residential lots (Lots 701 to 718 and 720 to 732). The site location is shown on Figure 1. The proposed subdivision is shown on Drawing 1, Appendix D.

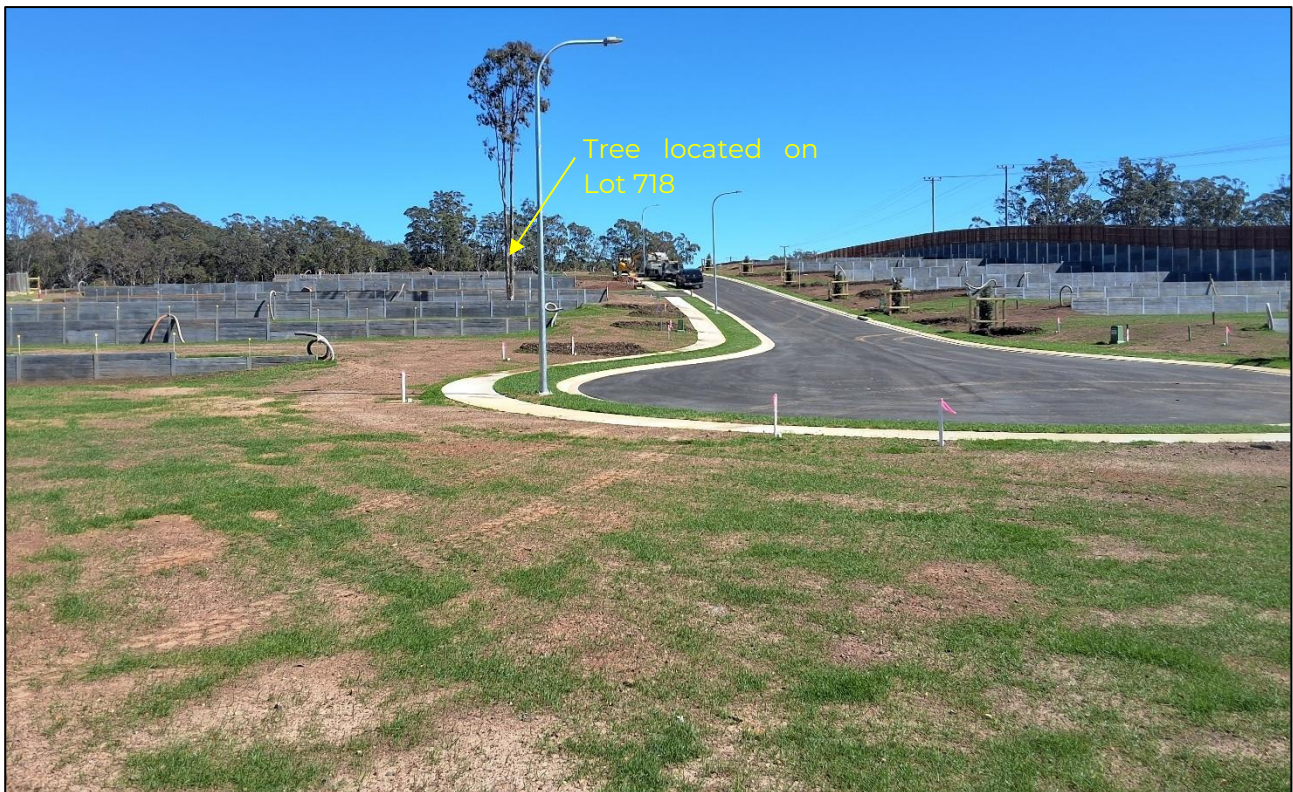
**Figure 2: View west of the northern part of the site**

The ground surface levels within each of the residential lots have gradients less than 5%. A tree approximately 20 m tall is present in the north-western part of Lot 718 located in the northern part of the site (refer Figure 2).

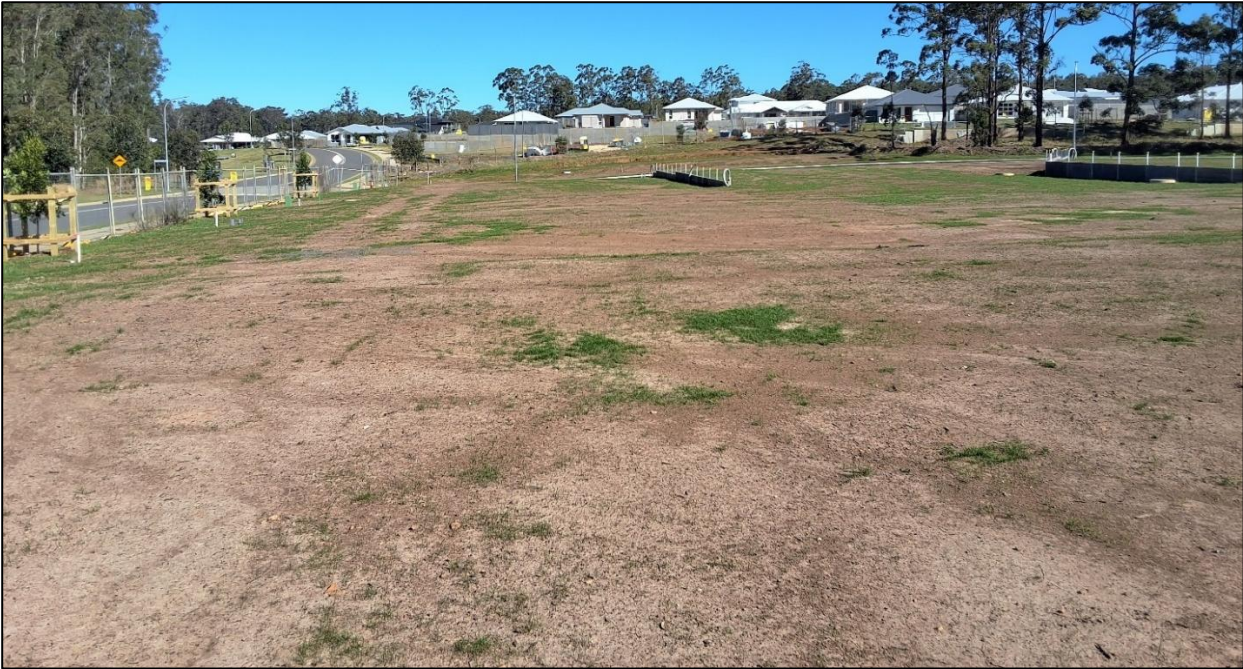
**Figure 3: View south of the southern part of the site**

Ground surface levels across the southern part of the site (Lots 726 to 732) fall towards the south-east at gradients less than 10%. Ground surface levels within the southern part of the site range from 9.6 m AHD in the south to 11.0 m AHD in the north-western part.

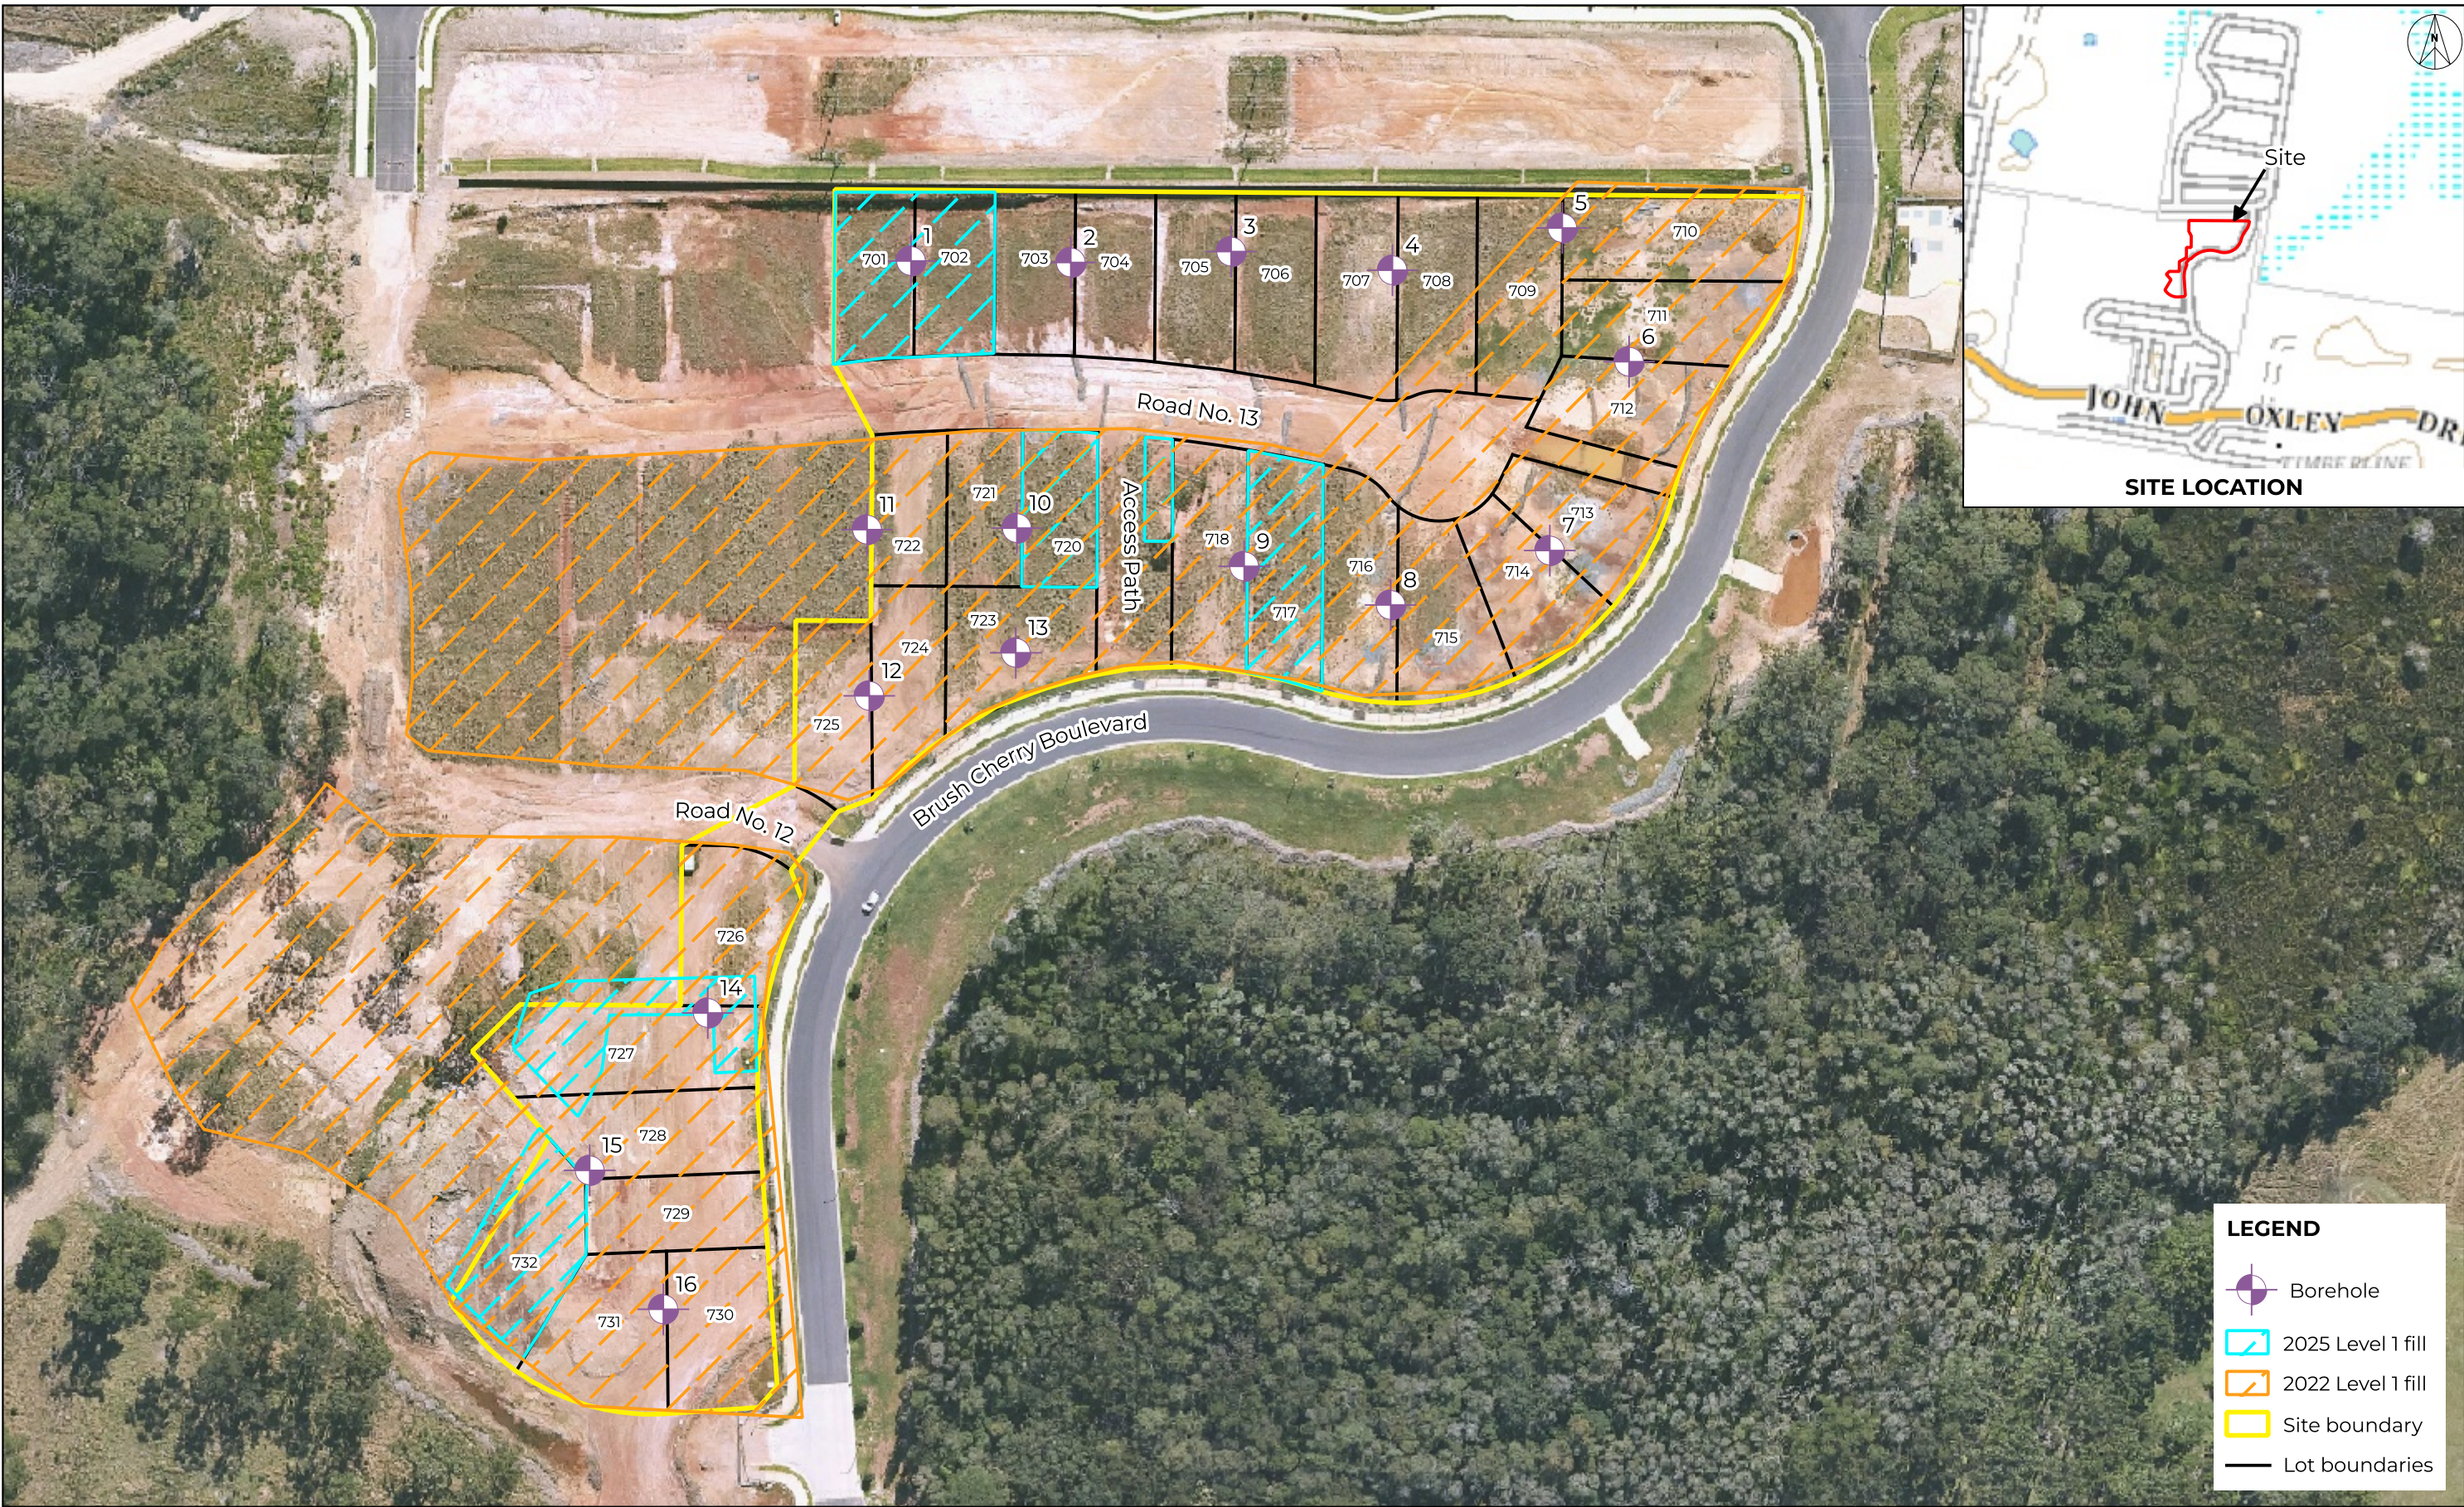
Drawing 1: Test Location Plan

NOTE:  
1. Drawing projection in GDA2020 / MGA zone 56, adapted from aerial imagery from Metromap dated 01.09.2024.  
2. Test locations are approximate only and were located using differential GPS typically accurate to  $\pm 0.1$  m depending on satellite coverage

It is considered that the placement and compaction of filling by DP during the period between 15 October 2021 to 18 March 2022 as shown on Drawing 1 was generally undertaken in accordance with the specification for layer thickness, compaction and moisture variation and to a Level 1 Standard, as defined in Section 8 of AS 3798 (2007).

The bores and DCPs were set out by an engineering geologist from Douglas relative to the lot boundaries and road alignments on site. The Douglas engineering geologist logged the subsurface profile at each test location and took regular samples for laboratory testing and identification purposes. The encountered subsurface ground conditions were logging in accordance with AS 1726, 2017. The test locations are shown on Drawing 1 in Appendix C.
