## **Report on Geotechnical Investigation**

### **Proposed Residential Subdivision**

**The Sanctuary Stages 5 and 6A, Lot 300 DP  
1307775 John Oxley Drive, Thrumster NSW**

**Project 209310.06**

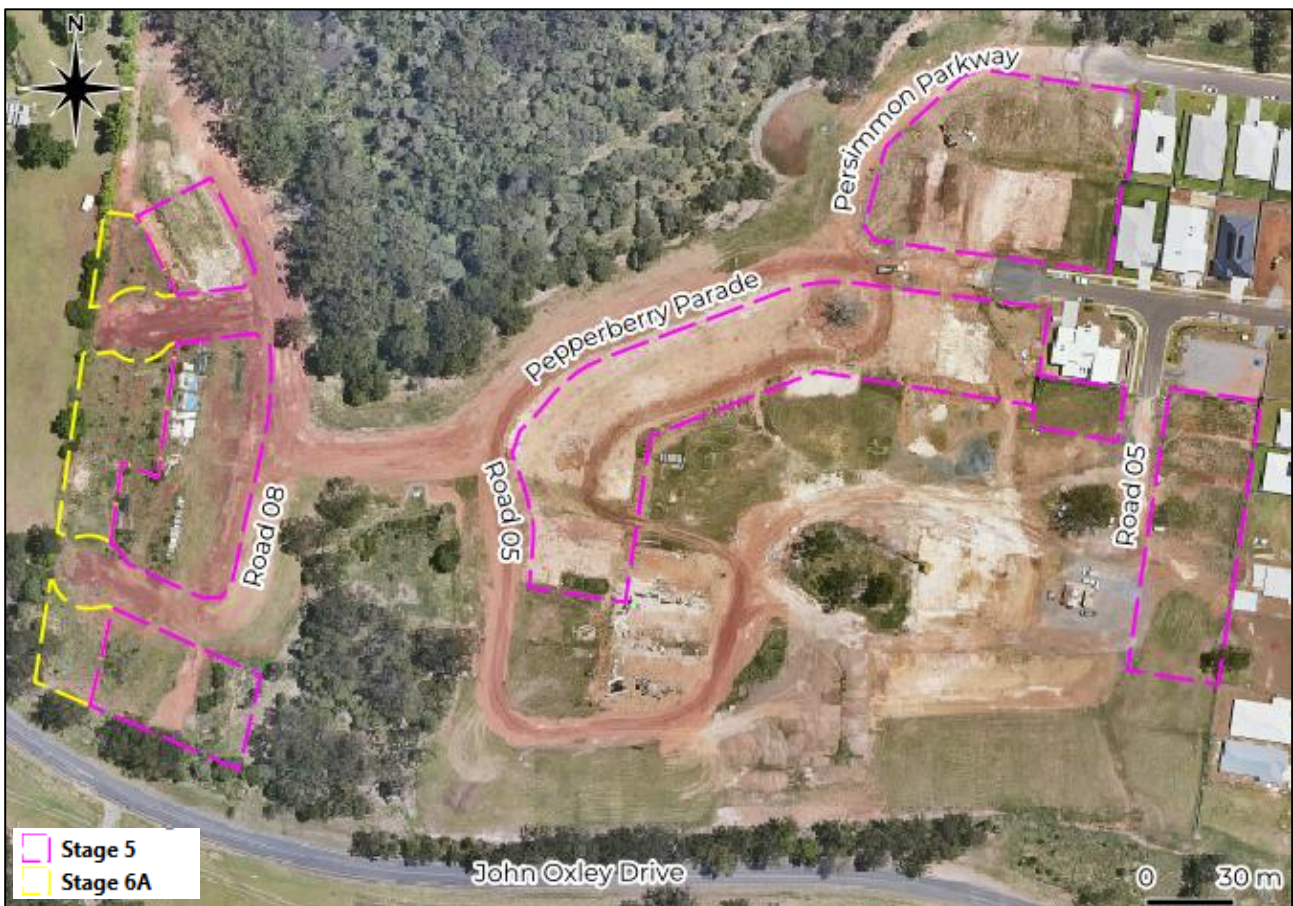
**Figure 1: Site location plan (image source: Metromap Image dated 8 April 2026)**

Stages 5 and 6A comprise forty-three (43) residential lots (Lots 501 to 538 and 603 to 607). The site location is shown on Figure 1. The proposed subdivision is shown on Drawing 1, Appendix D.

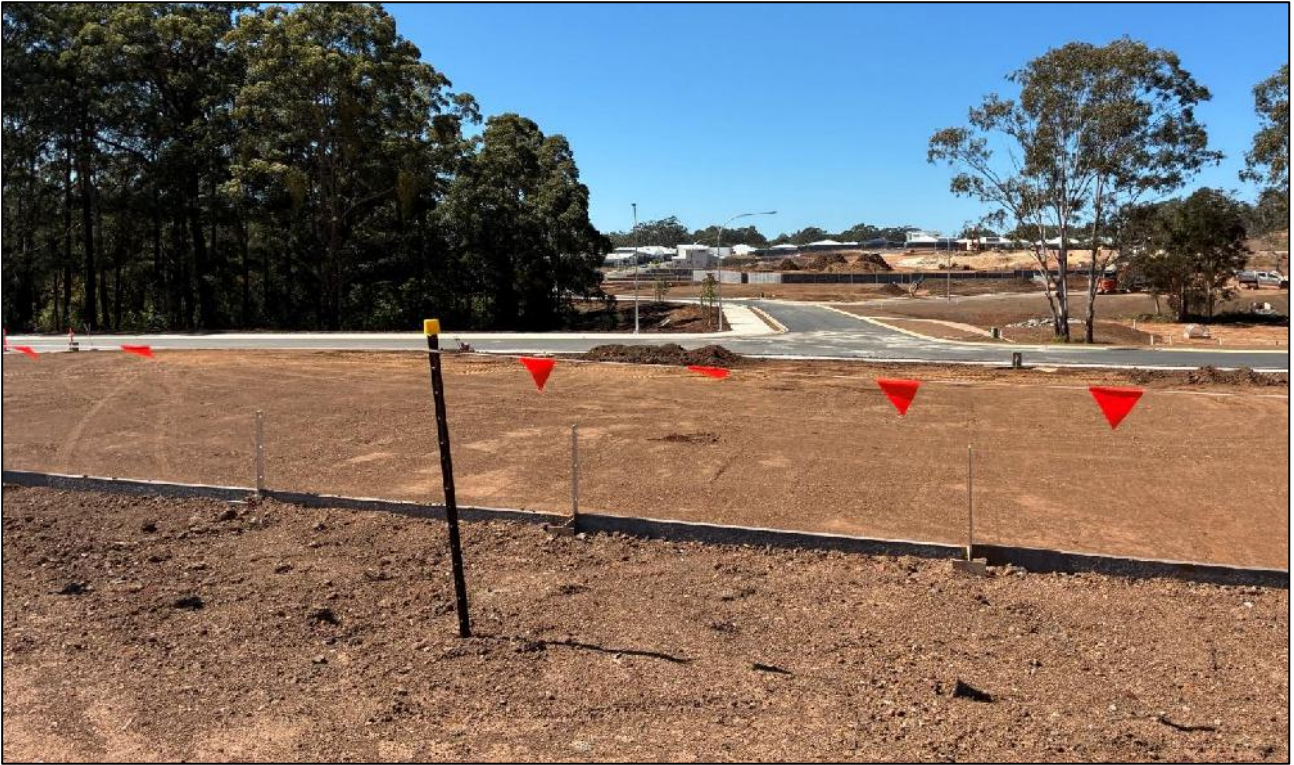
**Figure 2: View facing towards the east showing the western part of the site**

The overall ground surface levels across the western part of the site fall towards the east with an approximate gradient of 9%. Ground surface levels appear to range from RL 9 in the central part to RL 18 in the east.

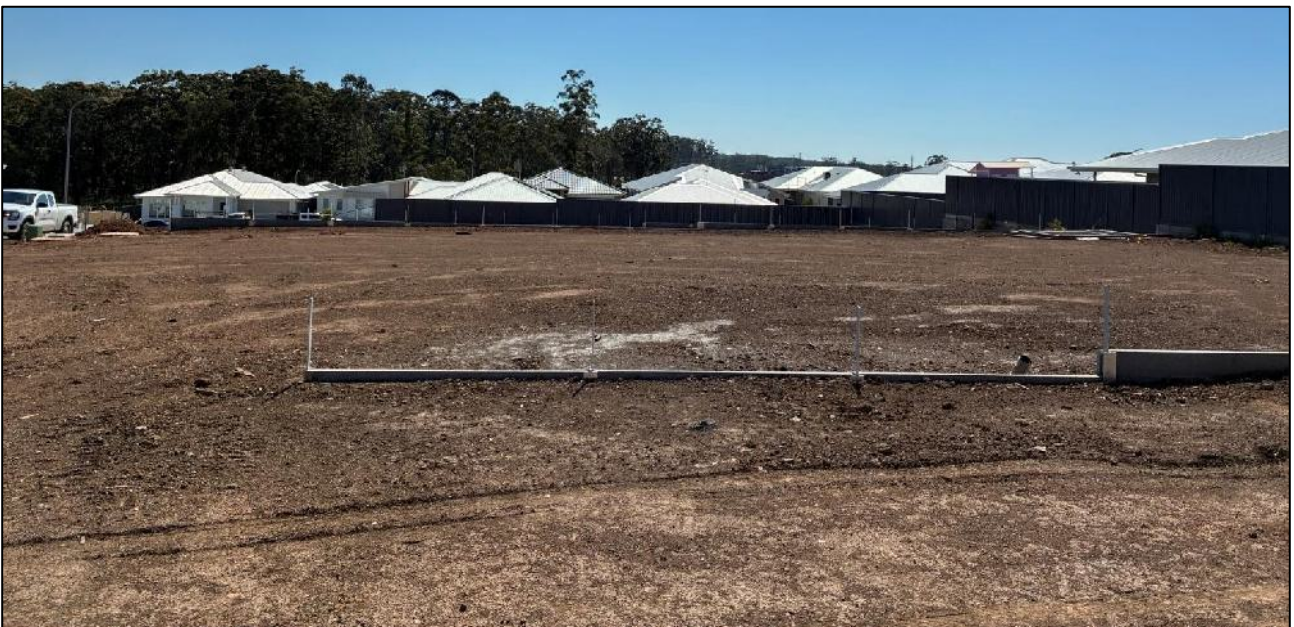
**Figure 3: View facing towards the north showing the south-eastern part of the site**

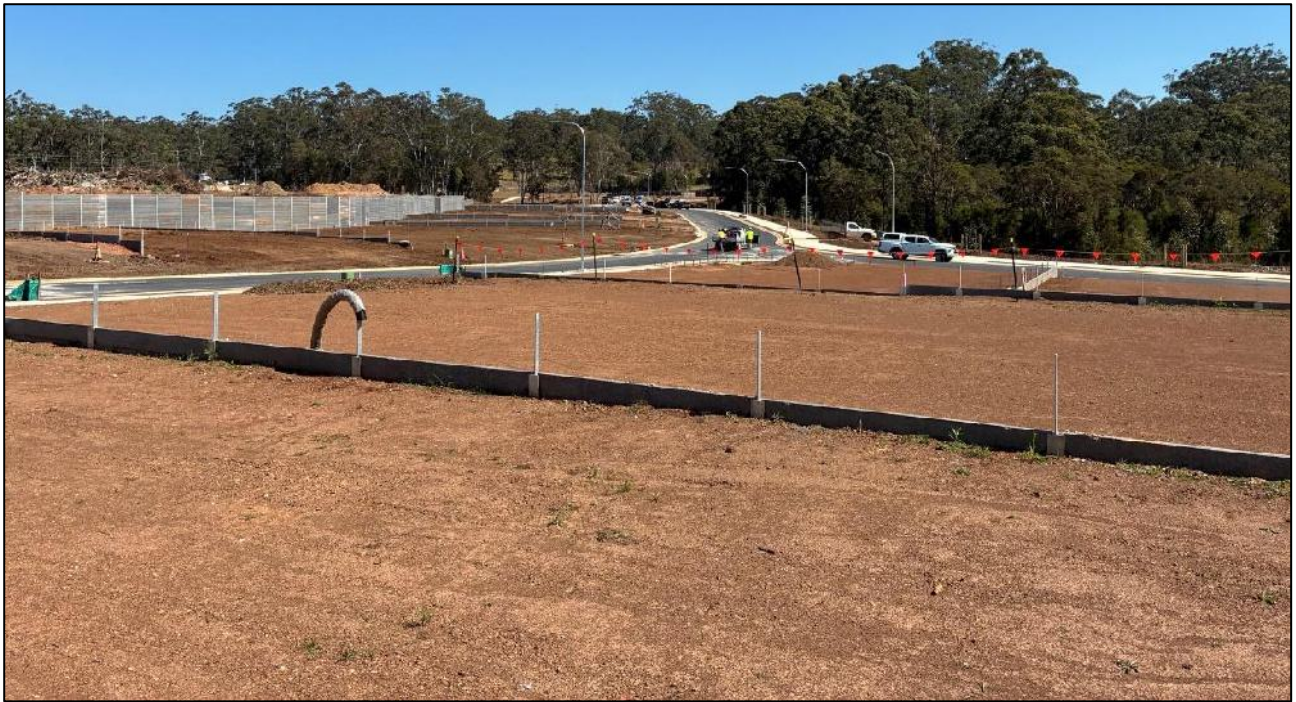
**Figure 4: View facing towards the south-west showing the eastern part of the site**

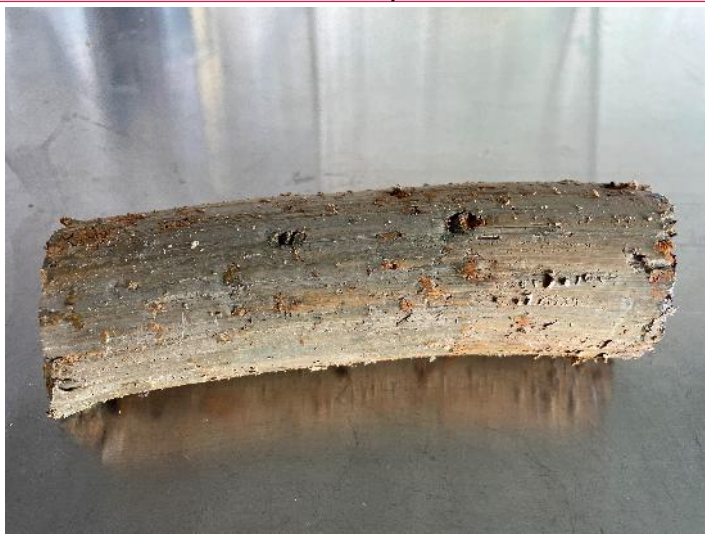
**Core Sample**

| Shrink Swell Index (AS 1289 7.1.1 & 2.1.1) | | Min | Max |
|---|---|---|---|
| Extent of Cracking | | Moderate | |
| Moisture Content (%) | | 29.0 | |
| Initial Moisture Content (%) | | 33.8 | |
| Final Moisture Content (%) | | 40.3 | |

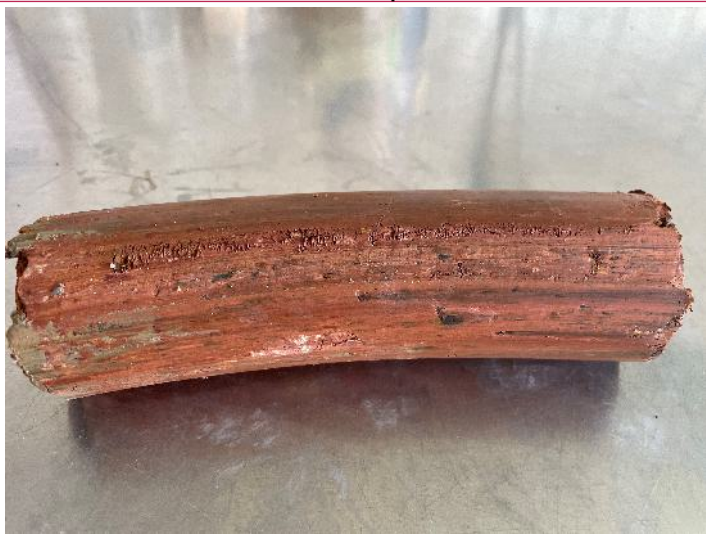
**Core Sample**

**Report Number:** 209310.06-1  
**Issue Number:** 2 - This version supersedes all previous issues  
**Reissue Reason:** Amended Material Descriptions  
**Date Issued:** 17/09/2026  
**Client:** Bird In The Hand 2 Pty Ltd  
Suite 103, 2 Miami Key, Broadbeach QLD  
**Contact:** Massimo Raniolo  
**Project Number:** 209310.06  
**Project Name:** Proposed Residential Subdivision  
**Project Location:** Lot 300 DP 1307775 John Oxley Drive, Thrumster NSW  
**Work Request:** 19268  
**Sample Number:** PM-19268B  
**Date Sampled:** 01/09/2026  
**Dates Tested:** 03/09/2026 - 07/09/2026  
**Sampling Method:** Sampled by Engineering Department  
The results apply to the sample as received  
**Sample Location:** 3, Depth: 0.3 - 0.5  
**Material:** Silty clay, red brown

| Core Shrinkage Test | |
|---|---|
| Extent of Cracking | Minor |
| Moisture Content (%) | 32.7 |

| Swell Test | |
|---|---|
| Initial Moisture Content (%) | 35.1 |
| Final Moisture Content (%) | 39.3 |

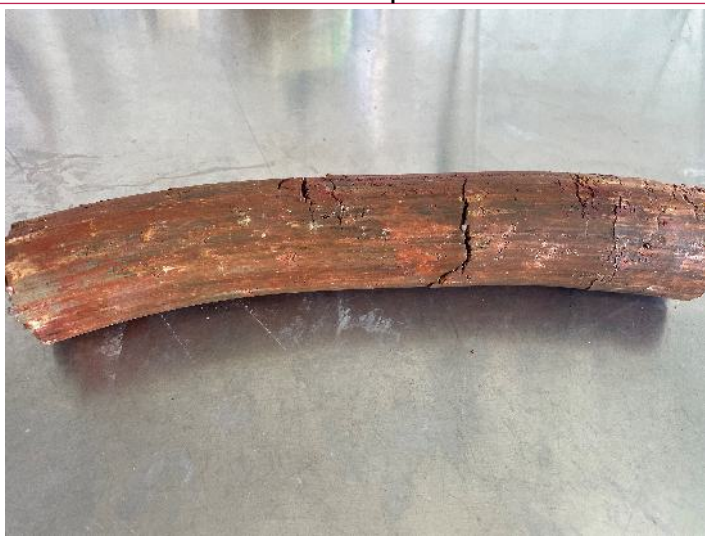
**Core Sample**

**Report Number:** 209310.06-1  
**Issue Number:** 2 - This version supersedes all previous issues  
**Reissue Reason:** Amended Material Descriptions  
**Date Issued:** 17/09/2026  
**Client:** Bird In The Hand 2 Pty Ltd  
Suite 103, 2 Miami Key, Broadbeach QLD  
**Contact:** Massimo Raniolo  
**Project Number:** 209310.06  
**Project Name:** Proposed Residential Subdivision  
**Project Location:** Lot 300 DP 1307775 John Oxley Drive, Thrumster NSW  
**Work Request:** 19268  
**Sample Number:** PM-19268C  
**Date Sampled:** 01/09/2026  
**Dates Tested:** 03/09/2026 - 07/09/2026  
**Sampling Method:** Sampled by Engineering Department  
The results apply to the sample as received  
**Sample Location:** 7, Depth: 0.4 - 0.7  
**Material:** Silty clay, brown mottled orange

| Shrink Swell Index (AS 1289 7.1.1 & 2.1.1) | | Min | Max |
|---|---|---|---|
| Extent of Cracking | | Minor | |
| Moisture Content (%) | | 26.4 | |
| Initial Moisture Content (%) | | 29.4 | |
| Final Moisture Content (%) | | 31.3 | |

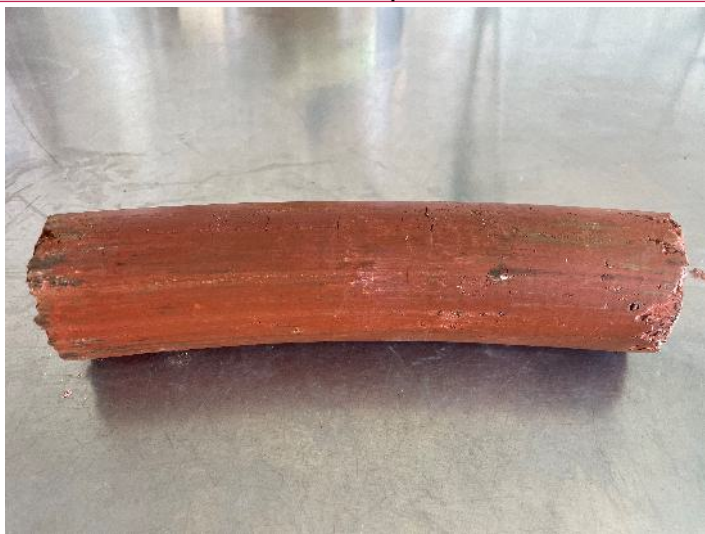
**Core Sample**

**Report Number:** 209310.06-1  
**Issue Number:** 2 - This version supersedes all previous issues  
**Reissue Reason:** Amended Material Descriptions  
**Date Issued:** 17/09/2026  
**Client:** Bird In The Hand 2 Pty Ltd  
Suite 103, 2 Miami Key, Broadbeach QLD  
**Contact:** Massimo Raniolo  
**Project Number:** 209310.06  
**Project Name:** Proposed Residential Subdivision  
**Project Location:** Lot 300 DP 1307775 John Oxley Drive, Thrumster NSW  
**Work Request:** 19268  
**Sample Number:** PM-19268D  
**Date Sampled:** 01/09/2026  
**Dates Tested:** 03/09/2026 - 07/09/2026  
**Sampling Method:** Sampled by Engineering Department  
The results apply to the sample as received  
**Sample Location:** 8, Depth: 0.45 - 0.67  
**Material:** Silty clay, red brown

| Shrink Swell Index (AS 1289 7.1.1 & 2.1.1) | | Min | Max |
|---|---|---|---|
| Extent of Cracking | | Minor | |
| Moisture Content (%) | | 38.1 | |
| Initial Moisture Content (%) | | 37.8 | |
| Final Moisture Content (%) | | 38.6 | |

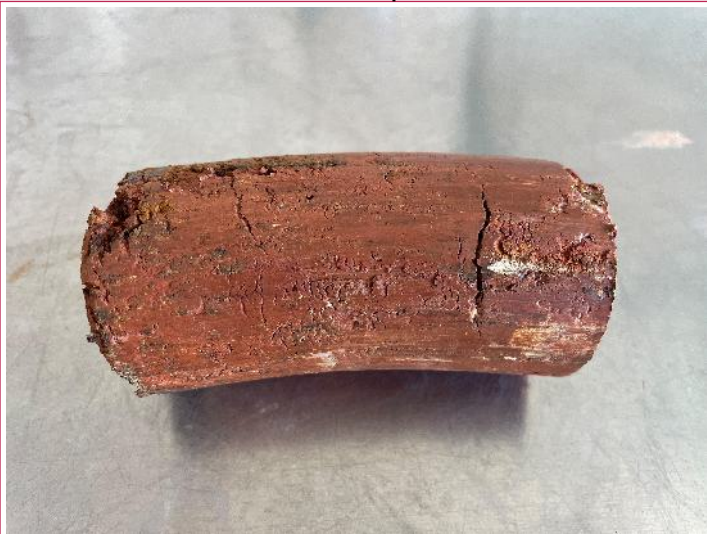
**Core Sample**

| Shrink Swell Index (AS 1289 7.1.1 & 2.1.1) | | Min | Max |
|---|---|---|---|
| Extent of Cracking | | Minor | |
| Moisture Content (%) | | 24.7 | |
| Initial Moisture Content (%) | | 25.0 | |
| Final Moisture Content (%) | | 30.6 | |

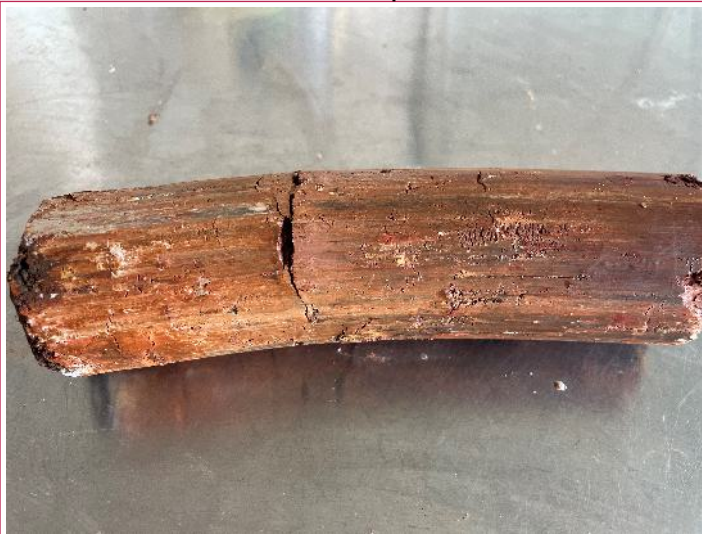
**Core Sample**

**Report Number:** 209310.06-1  
**Issue Number:** 2 - This version supersedes all previous issues  
**Reissue Reason:** Amended Material Descriptions  
**Date Issued:** 17/09/2026  
**Client:** Bird In The Hand 2 Pty Ltd  
Suite 103, 2 Miami Key, Broadbeach QLD  
**Contact:** Massimo Raniolo  
**Project Number:** 209310.06  
**Project Name:** Proposed Residential Subdivision  
**Project Location:** Lot 300 DP 1307775 John Oxley Drive, Thrumster NSW  
**Work Request:** 19268  
**Sample Number:** PM-19268H  
**Date Sampled:** 01/09/2026  
**Dates Tested:** 03/09/2026 - 07/09/2026  
**Sampling Method:** Sampled by Engineering Department  
The results apply to the sample as received  
**Sample Location:** 15 , Depth: 0.4 - 0.55  
**Material:** Silty clay, red mottled orange brown

| Shrink Swell Index (AS 1289 7.1.1 & 2.1.1) | | Min | Max |
|---|---|---|---|
| Extent of Cracking | | Minor | |
| Moisture Content (%) | | 25.6 | |
| Initial Moisture Content (%) | | 24.4 | |
| Final Moisture Content (%) | | 27.6 | |

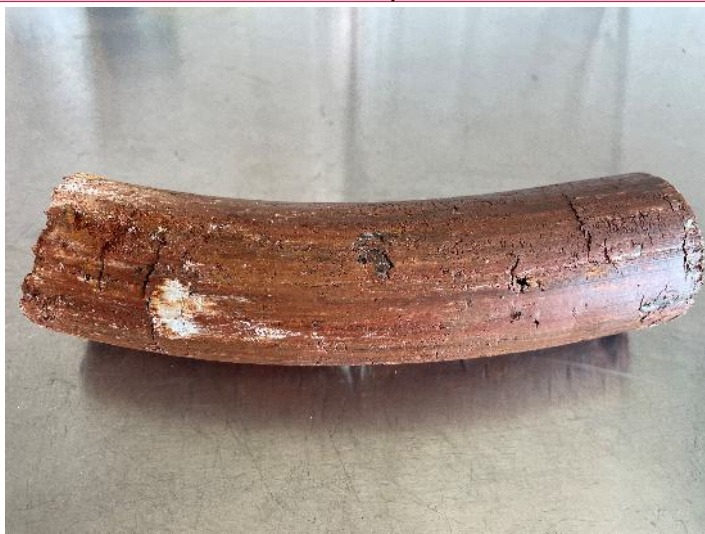
Core Sample

**Report Number:** 209310.06-1  
**Issue Number:** 2 - This version supersedes all previous issues  
**Reissue Reason:** Amended Material Descriptions  
**Date Issued:** 17/09/2026  
**Client:** Bird In The Hand 2 Pty Ltd  
Suite 103, 2 Miami Key, Broadbeach QLD  
**Contact:** Massimo Raniolo  
**Project Number:** 209310.06  
**Project Name:** Proposed Residential Subdivision  
**Project Location:** Lot 300 DP 1307775 John Oxley Drive, Thrumster NSW  
**Work Request:** 19268  
**Sample Number:** PM-19268I  
**Date Sampled:** 01/09/2026  
**Dates Tested:** 03/09/2026 - 09/09/2026  
**Sampling Method:** Sampled by Engineering Department  
The results apply to the sample as received  
**Sample Location:** 18 , Depth: 0.35 - 0.55  
**Material:** Silty clay, brown mottled red

| Shrink Swell Index (AS 1289 7.1.1 & 2.1.1) | | Min | Max |
|---|---|---|---|
| Extent of Cracking | | Minor | |
| Moisture Content (%) | | 21.4 | |
| Initial Moisture Content (%) | | 25.8 | |
| Final Moisture Content (%) | | 27.4 | |

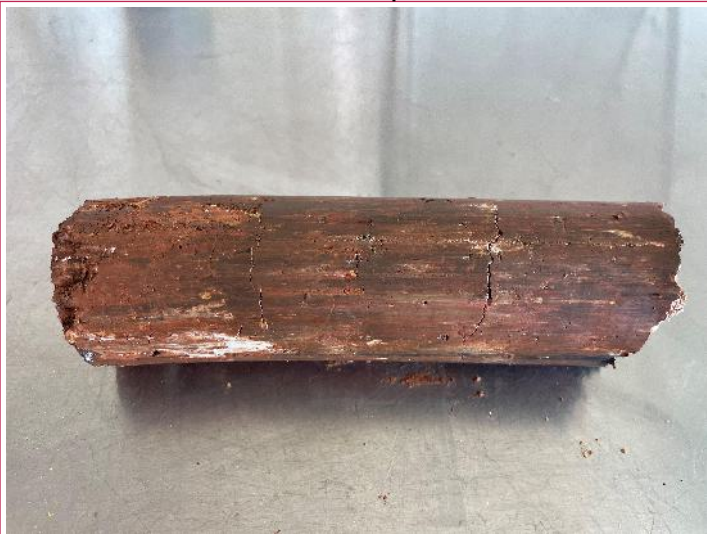
**Core Sample**

**Report Number:** 209310.06-1  
**Issue Number:** 2 - This version supersedes all previous issues  
**Reissue Reason:** Amended Material Descriptions  
**Date Issued:** 17/09/2026  
**Client:** Bird In The Hand 2 Pty Ltd  
Suite 103, 2 Miami Key, Broadbeach QLD  
**Contact:** Massimo Raniolo  
**Project Number:** 209310.06  
**Project Name:** Proposed Residential Subdivision  
**Project Location:** Lot 300 DP 1307775 John Oxley Drive, Thrumster NSW  
**Work Request:** 19268  
**Sample Number:** PM-19268J  
**Date Sampled:** 01/09/2026  
**Dates Tested:** 03/09/2026 - 09/09/2026  
**Sampling Method:** Sampled by Engineering Department  
The results apply to the sample as received  
**Sample Location:** 20 , Depth: 0.5 - 0.75  
**Material:** Silty clay, brown mottled red

| Shrink Swell Index (AS 1289 7.1.1 & 2.1.1) | | Min | Max |
|---|---|---|---|
| Extent of Cracking | | Minor | |
| Moisture Content (%) | | 22.4 | |
| Initial Moisture Content (%) | | 20.5 | |
| Final Moisture Content (%) | | 28.1 | |
| Initial Bulk Density (t/m <sup>3</sup> ) | | 1.939 | |

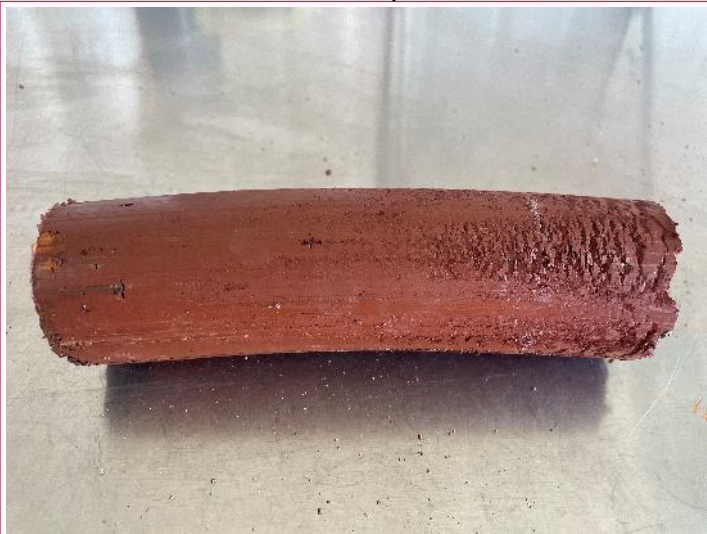
**Core Sample**

**Report Number:** 209310.06-1  
**Issue Number:** 2 - This version supersedes all previous issues  
**Reissue Reason:** Amended Material Descriptions  
**Date Issued:** 17/09/2026  
**Client:** Bird In The Hand 2 Pty Ltd  
Suite 103, 2 Miami Key, Broadbeach QLD  
**Contact:** Massimo Raniolo  
**Project Number:** 209310.06  
**Project Name:** Proposed Residential Subdivision  
**Project Location:** Lot 300 DP 1307775 John Oxley Drive, Thrumster NSW  
**Work Request:** 19268  
**Sample Number:** PM-19268K  
**Date Sampled:** 01/09/2026  
**Dates Tested:** 03/09/2026 - 09/09/2026  
**Sampling Method:** Sampled by Engineering Department  
The results apply to the sample as received  
**Sample Location:** 23, Depth: 0.4 - 0.6  
**Material:** Silty clay, red brown

| Shrink Swell Index (AS 1289 7.1.1 & 2.1.1) | | Min | Max |
|---|---|---|---|
| Extent of Cracking | | Minor | |
| Moisture Content (%) | | 37.7 | |
| Initial Moisture Content (%) | | 41.3 | |
| Final Moisture Content (%) | | 43.8 | |

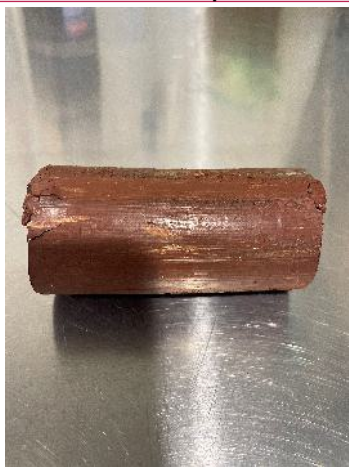
Core Sample

**Report Number:** 209310.06-1  
**Issue Number:** 2 - This version supersedes all previous issues  
**Reissue Reason:** Amended Material Descriptions  
**Date Issued:** 17/09/2026  
**Client:** Bird In The Hand 2 Pty Ltd  
Suite 103, 2 Miami Key, Broadbeach QLD  
**Contact:** Massimo Raniolo  
**Project Number:** 209310.06  
**Project Name:** Proposed Residential Subdivision  
**Project Location:** Lot 300 DP 1307775 John Oxley Drive, Thrumster NSW  
**Work Request:** 19268  
**Sample Number:** PM-19268L  
**Date Sampled:** 01/09/2026  
**Dates Tested:** 03/09/2026 - 09/09/2026  
**Sampling Method:** Sampled by Engineering Department  
The results apply to the sample as received  
**Sample Location:** 25 , Depth: 0.3 - 0.5  
**Material:** Silty clay, red brown

| Shrink Swell Index (AS 1289 7.1.1 & 2.1.1) | | Min | Max |
|---|---|---|---|
| Extent of Cracking | | Minor | |
| Moisture Content (%) | | 35.3 | |
| Initial Moisture Content (%) | | 37.5 | |
| Final Moisture Content (%) | | 40.0 | |

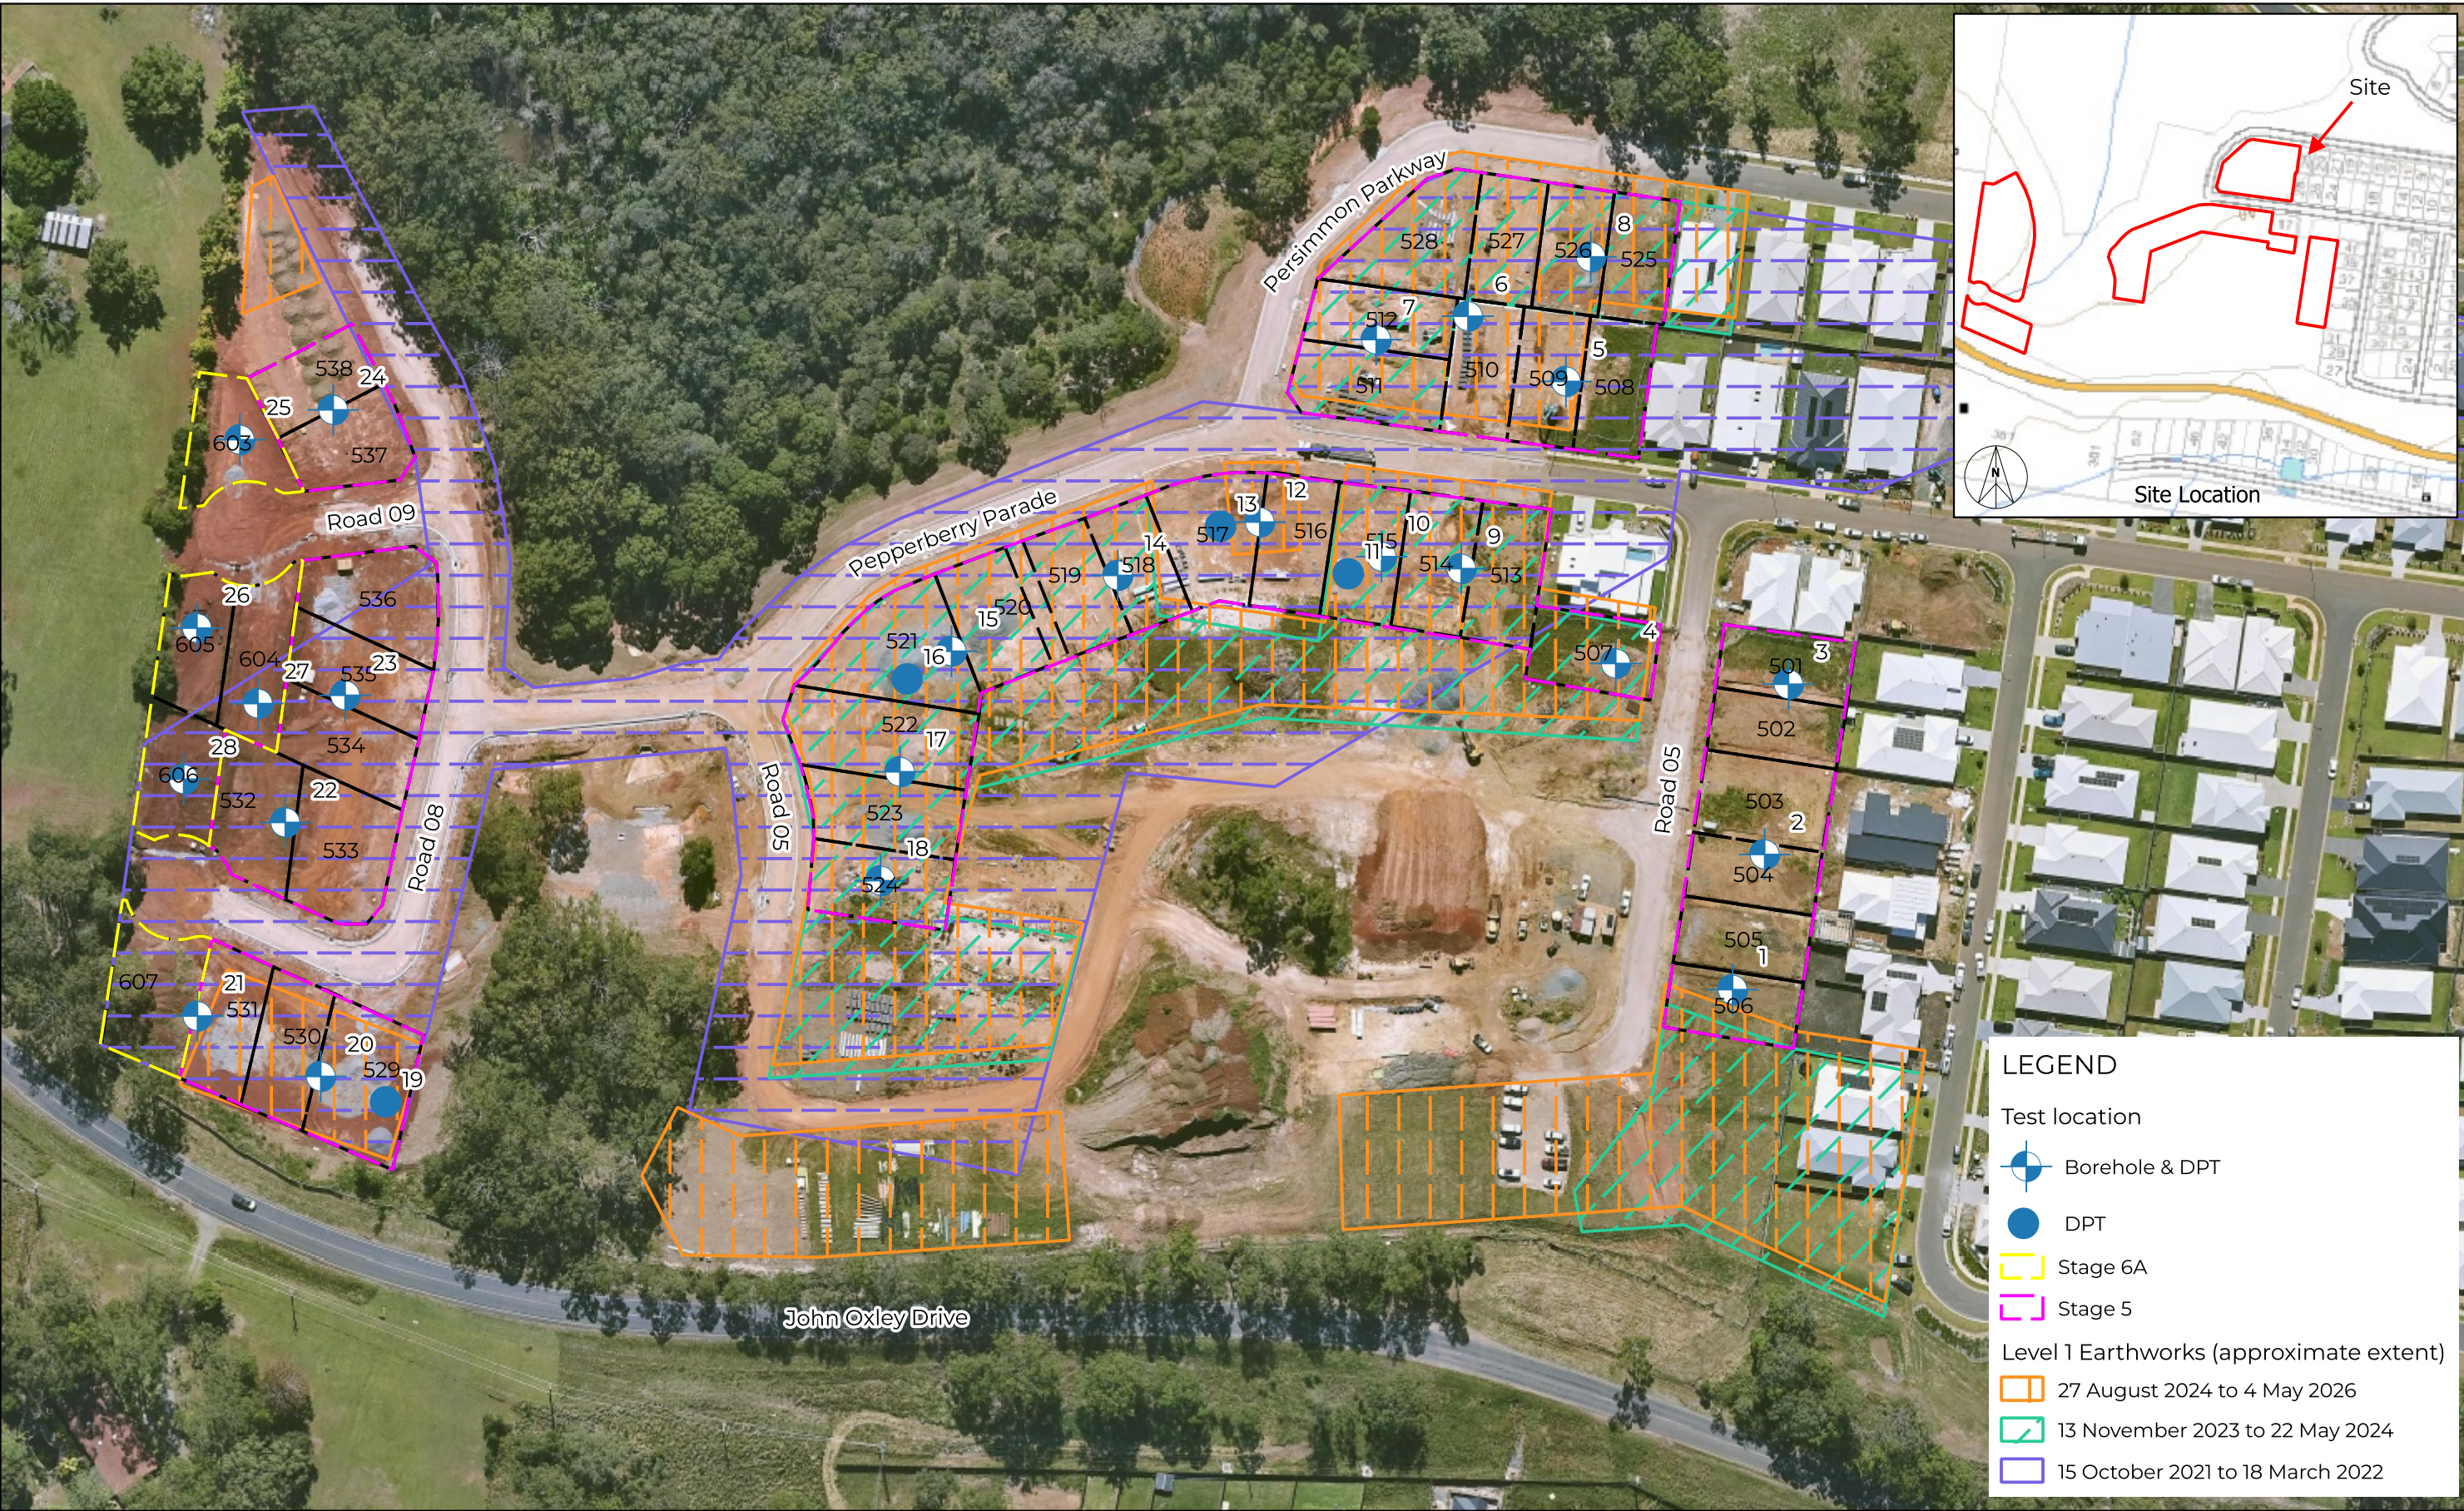
Drawing 1 – Test Location Plan

NOTE:  
1. Drawing projection in GDA2020 / MGA zone 56, adapted from aerial imagery from Metromap dated 8 April 2026,  
2. Test locations are approximate only and were located using differential GPS typically accurate to  $\pm 0.1$  m depending on satellite coverage

The bores and DPTs were set out by an engineer from Douglas relative to the lot boundaries and road alignments on site. The Douglas engineer logged the subsurface profile in accordance with AS 1726 (2017) at each test location and took regular samples for laboratory testing and identification purposes. The encountered subsurface ground conditions were logged in accordance with AS 1726, 2017. The test locations are shown on Drawing 1 in Appendix C.
